SURFACE FLASHOVER ARC ORIENTATION ON MYLAR FILM

M. Gossland and K.G. Balmain Department of Electrical Engineering University of Toronto Toronto, Canada M5S 1A4

Abstract

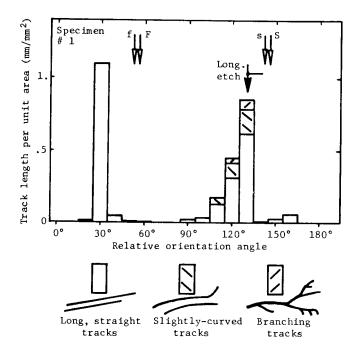
The results of this survey are presented in the histograms of Figs.13 and 14 which show the high degree of order in the track directions. In Fig.14 the data have been adjusted to a common 0° reference axis in order to facilitate a direct comparison of the noteworthy features. Also included in Fig.14 and depicted by the horizontal line through the arrow labelled "arcs" is the angular range of arcs observed in Fig.1 as measured with ± 3 ° accuracy. Further discussion of these features is reserved for a later section of the paper.

The discharge tracks exhibit a striking tendency to follow certain preferred directions. With each specimen the angular distribution of tracks consists of a narrow, prominent peak composed primarily of long, straight and parallel tracks of type 1, a broader secondary peak and a sector in which few or no tracks were observed. This empty sector, which is of the order of 70° wide, in each case encompasses the fast optical direction, indicating that the discharges tend to avoid this direction.

Fig.13 Discharge damage track angular distribution for 75 μ m 30 cm² Mylar, compared with optical directions and etch-mark directions. Symbols:

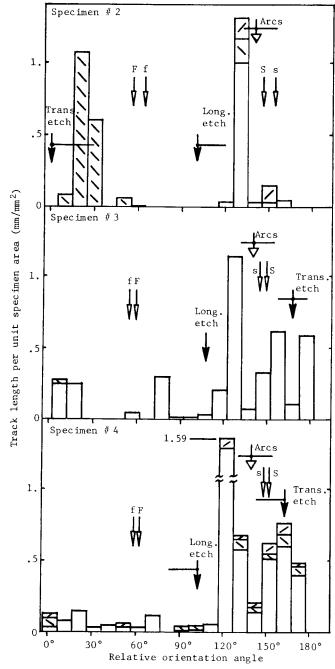
Evidence also suggests that the visible arc direction is aligned with the principal damage track direction. Any disagreement may possibly be due to the fact that the arc directions are averaged over a meter-diameter region while the damage tracks are studied on $17~\mathrm{mm}^2$ of the specimens. Equally strong evidence suggests that the visible arc direction is associated with the slow optical axis. However one can only conclude that a large fraction of the damage tracks align with the slow optical axis to within approximately $\pm 30~^\circ$ which is 3 times greater than the measurement uncertainties involved.

Fig.14 Same as Fig.13, but for meter-diameter Mylar.
